Assessment of the Status of Traditional Water Harvesting Systems (Kalyanis) in Suvarnamukhi Watershed, Tumkur District, Karnataka State Using Geospatial Technologies

Research Article**Corresponding author***ABSTRACT**

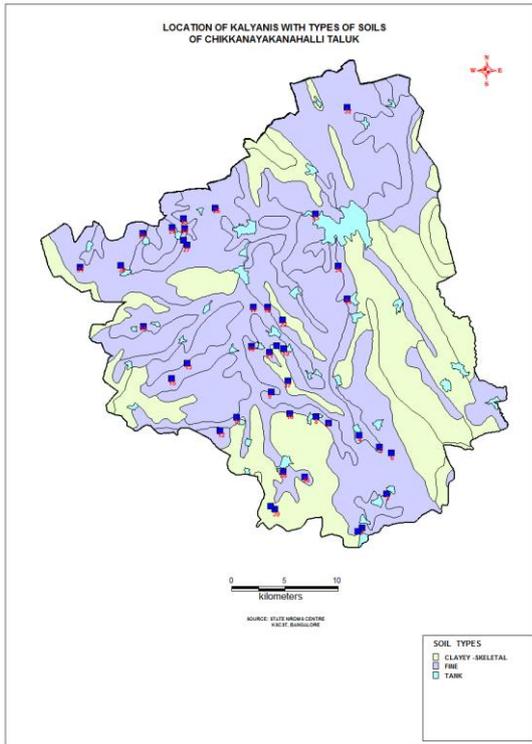
Fig .6. Kalyanis superimposed on Types of Soil

- Geo-tagging of photographs using Geospatial technologies as shown in figure no.1&2
- Linking, integration and Superimposition of different layers for Analysis- Drainage, Soil, Land use/Land cover, etc as shown in Fig nos 3,4,5 and 6.

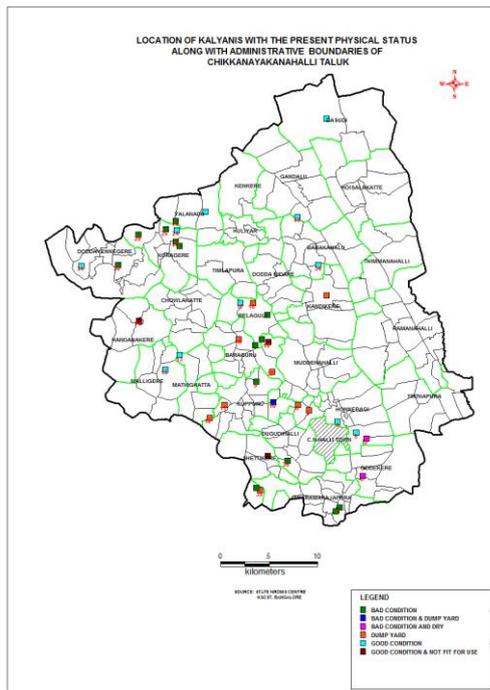
Fig .7. Physical status of Kalyanis

- Analysed and categorized the Kalyanis based on their physical status, functionality, type of usage and water availability as shown in fig no.7
- Analysed and categorized the Kalyanis based on water quality parameters on p^H , TDS, Nitrate, Iron, EC and Fluoride as shown in fig no.8

From the study it was found that, the status of more than 18 Kalyanis are really poor in both the taluks (Chikkanayakanahalli & Madugiri) and these Kalyanis are not properly maintained or cleaned periodically. More than 9 Kalyanis have become dump yard as they have been ignored by both community and Panchayath Raj Institutions. But there are few of the Kalyanis in Chikkanayakanahalli which are under proper use and maintained well. The water from these Kalyanis is mainly used for temple and domestic purpose as well as agriculture purpose.

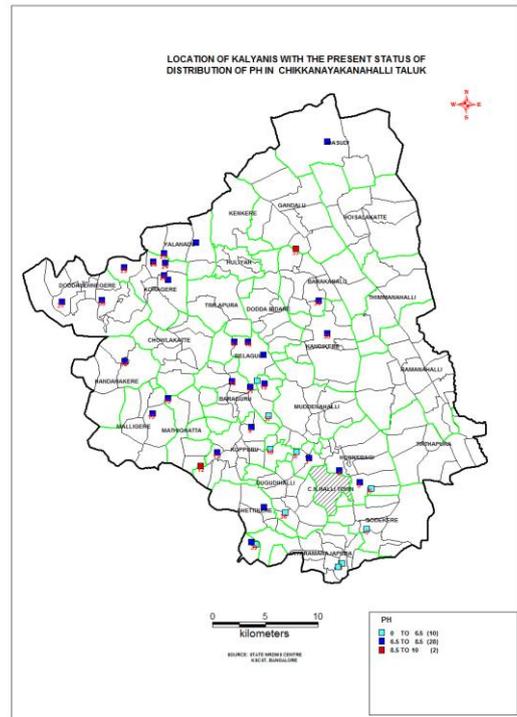
Fig .8. Distribution of pH

Water quality analysis for pH, Nitrate, EC, TDS, Iron and Fluoride parameters has been carried out for Kalyanis those having water and it was found that some kalyanis polluted with chemical components having more than permissible limits. The categorization has been carried out based on their status and shown in table no.2

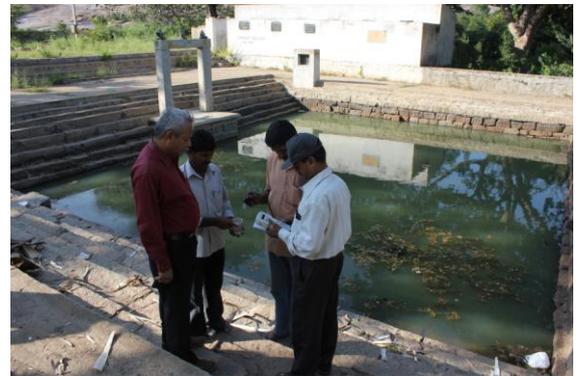
Fig.9: Physical survey of Kalyani
