EVALUATING THE STRUCTURAL BEHAVIOUR AND SUITABILITY OF SURFACE REPAIR MATERIAL USED FOR REPAIRING OF CONCRETE STRUCTURAL ELEMENTS.

Project Reference No.: 47S_BE_2375

College : The National Institute of Engineering, Mysuru

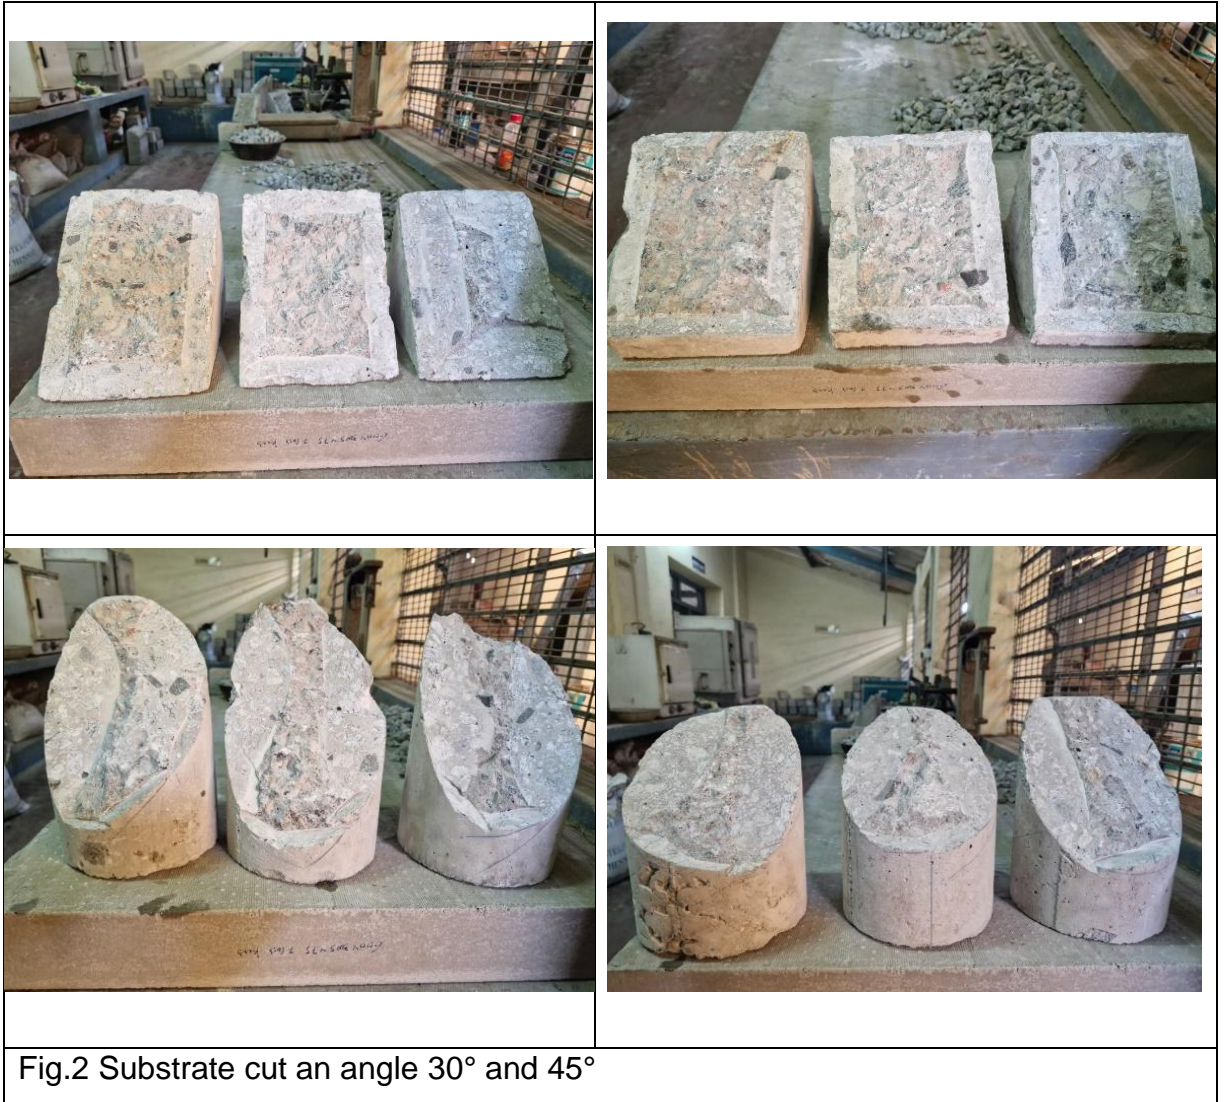
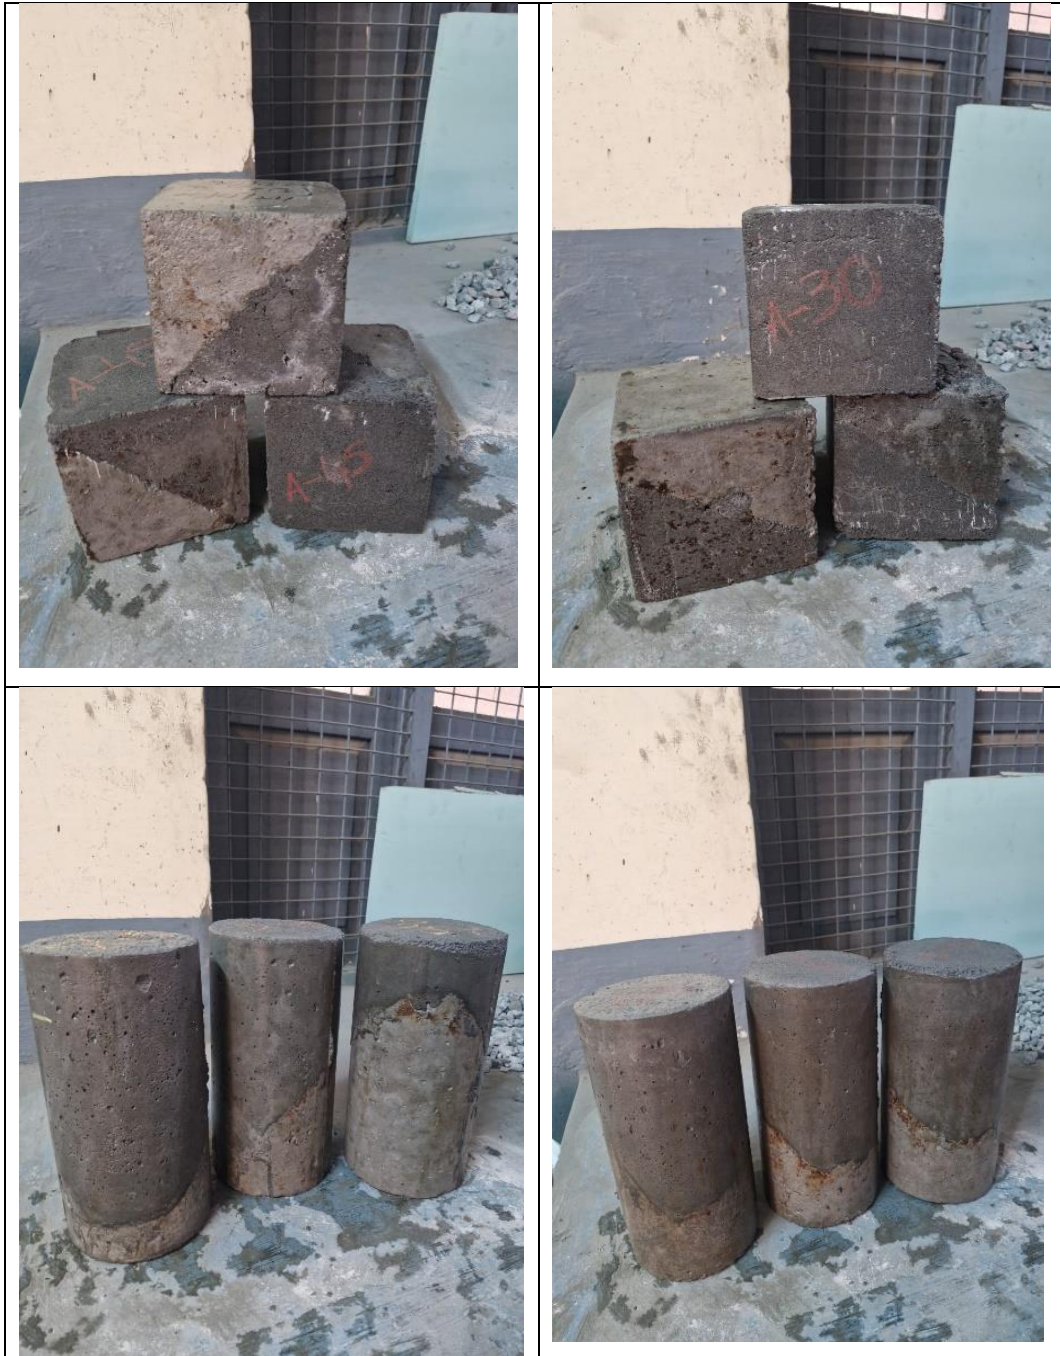
Fig.3 Combination of substrate with repair material

One of the most common types of bonding tests is “Slant Shear Test” in which the interface is under combined state of compression and shear stresses. The procedure involves diagonally cutting a half section of hardened substrate at 30° and 45° from the horizontal and bonding it to new repair material, forming a complete cylinder or cube as **shown in fig 3**.

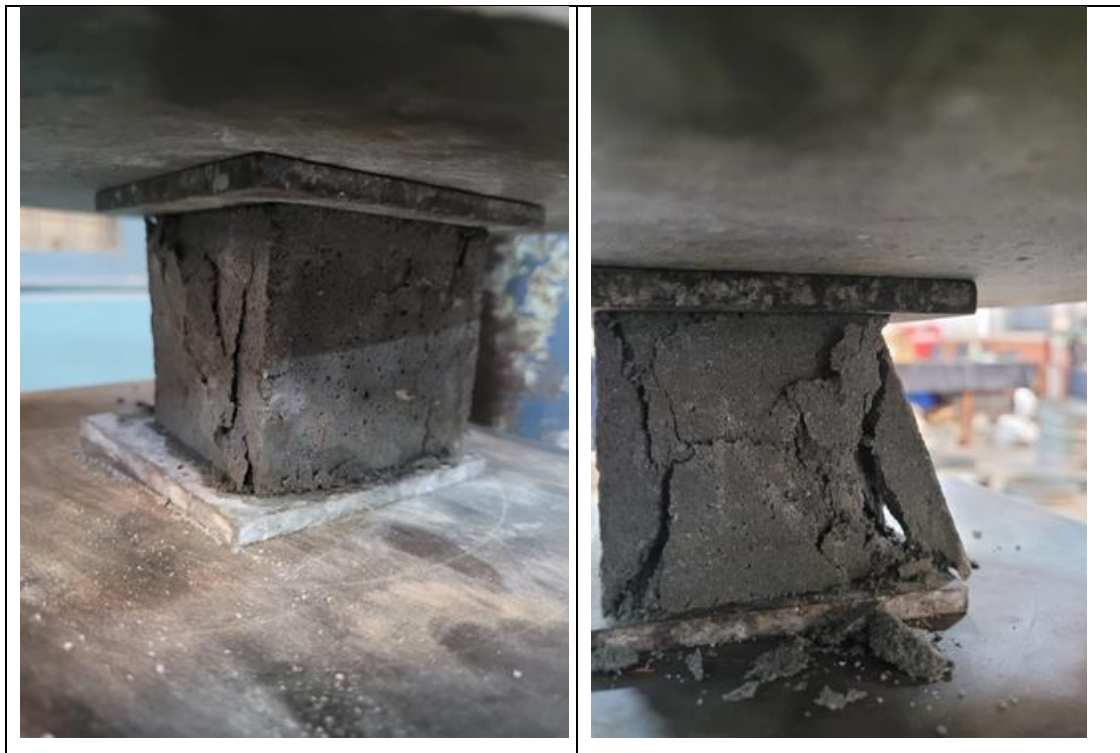
Fig: 4 Debonding failure of Asian paints repair mortar

The blended cement repair mortar demonstrated the highest compressive strength followed by the Asian Paints and the Sika polymer modified repair mortars. This suggests that the composition and formulation of the blended cement mortar contributed to its superior compressive strength compared to the other two types of mortar. The failure types observed provide insights into the behavior of each type of repair mortar under compressive stress. The presence of debonding in the Asian Paints repair mortar may indicate inadequate adhesion potentially affecting its overall

performance. **Fig:4.** The occurrence of vertical cracks in the Sika repair mortar suggests that it might have experienced localized tensile stresses during compression, leading to crack formation. **Fig:5.** The observation of minor cracks in samples falling within the category of unsatisfactory failures indicates an abnormal or unacceptable level of cracking for cube samples, as shown in **Fig:6.** Satisfactory failure is characterized by cracking and failure of specimens at the peak applied load, with all four sides exposed with uniform cracks while the top and bottom faces remain undamaged or sustain only minor cracks. **Fig:6** representing unsatisfactory failure suggests that the specimen has developed more strength due to inadequate mix proportions, inconsistent particle sizes, and influences from the water-cement ratio. The coefficient of variation reflects the variability or dispersion of compressive strength values within each set of samples. The lowest coefficient of variation was observed in the blended cement repair mortar indicating a relatively consistent performance across samples. In contrast, the Sika repair mortar exhibited a higher coefficient of variation suggesting greater variability in compressive strength among samples. The Asian Paints repair mortar fell in between the two. This variability could be attributed to factors such as material homogeneity, curing conditions, and testing methodologies.

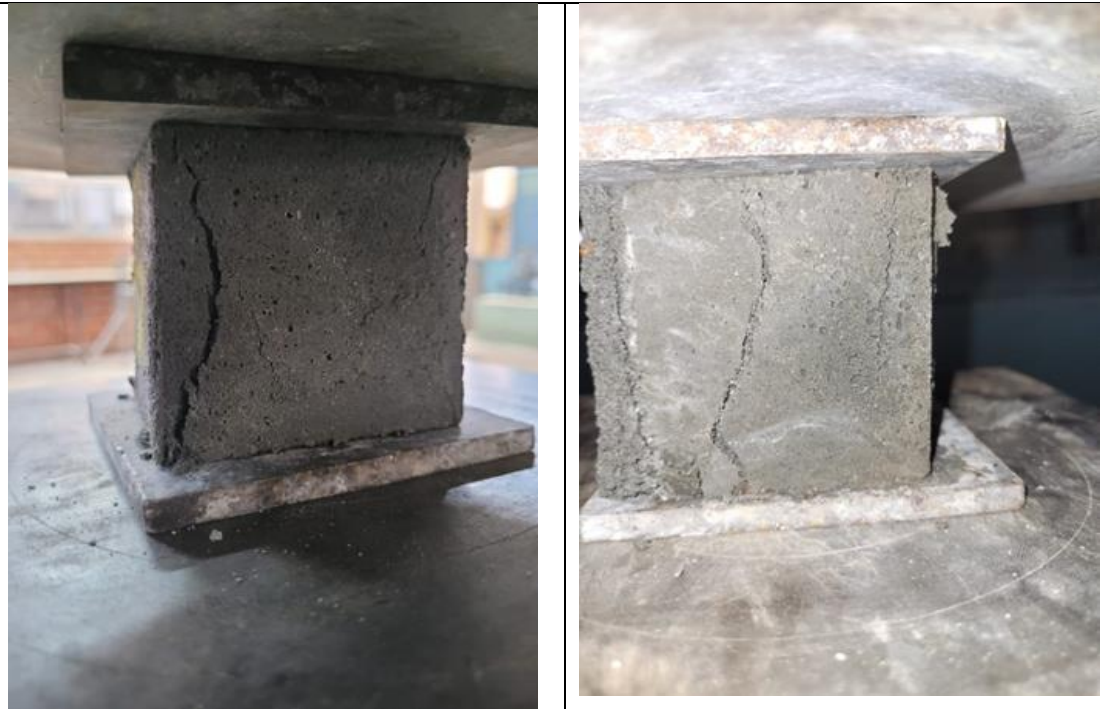
Fig: 5 Vertical failure of Sika latex power repair mortar

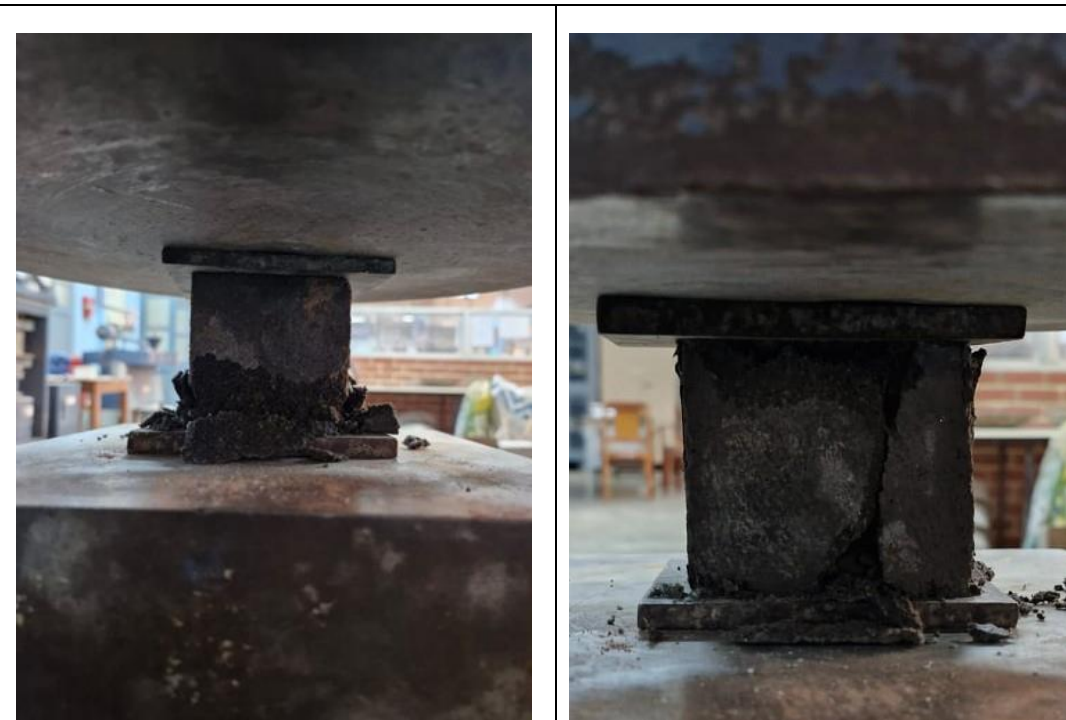
Fig: 6 Unsatisfactory failure of Blended mortar

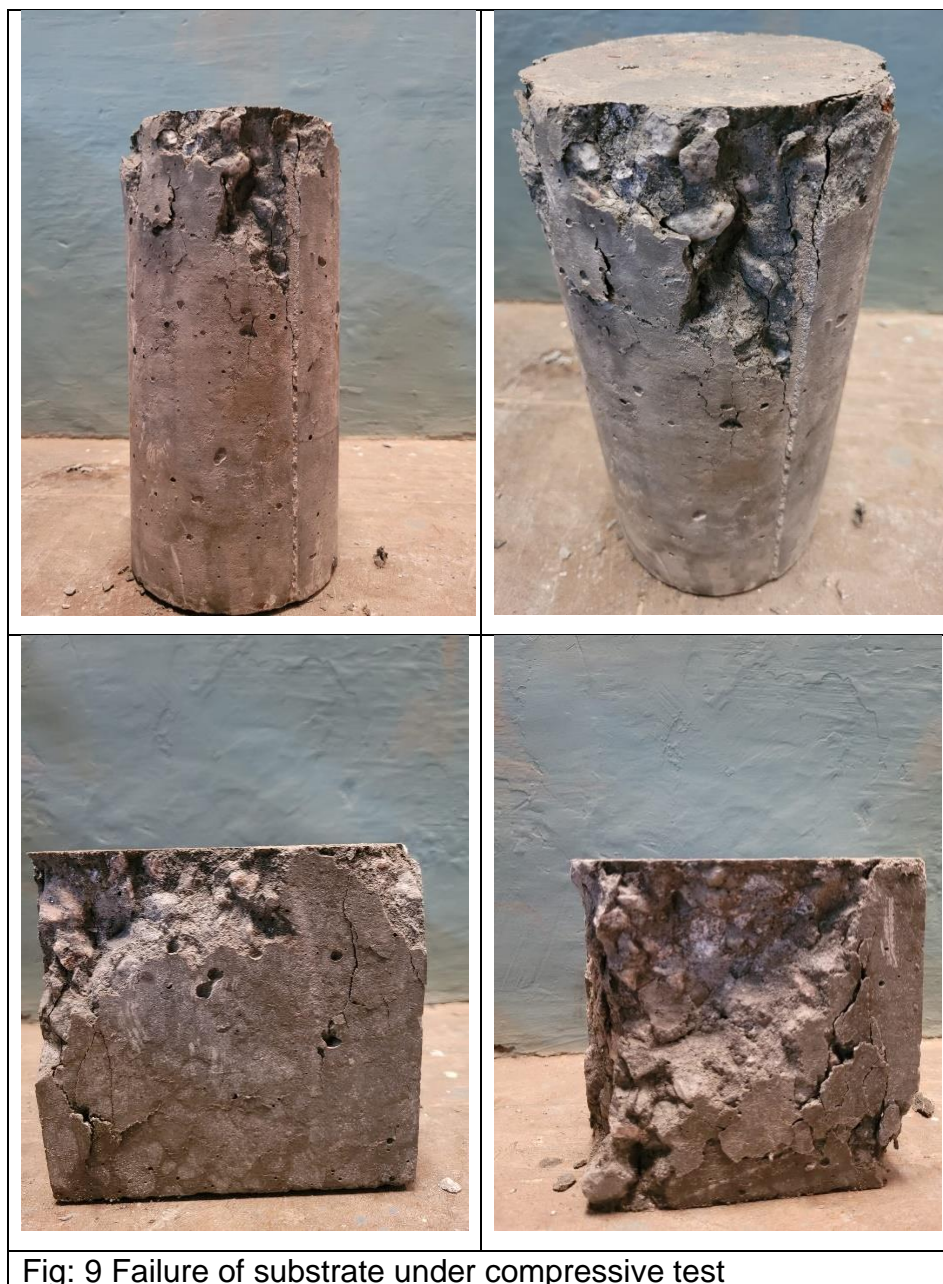
Fig: 9 Failure of substrate under compressive test

Compressive Strength of concrete cubes and cylinders were conducted as per IS :516 2016. We employed M30 grade concrete with appropriate mix proportion as per IS:10262: 2019. Compressive strength is critical for evaluating the overall structural performance and durability of concrete. Higher compressive strength often correlates with better performance in resisting various types of loads, including shear. Although slant shear tests directly measure shear strength, this strength is influenced by the concrete's overall strength properties.

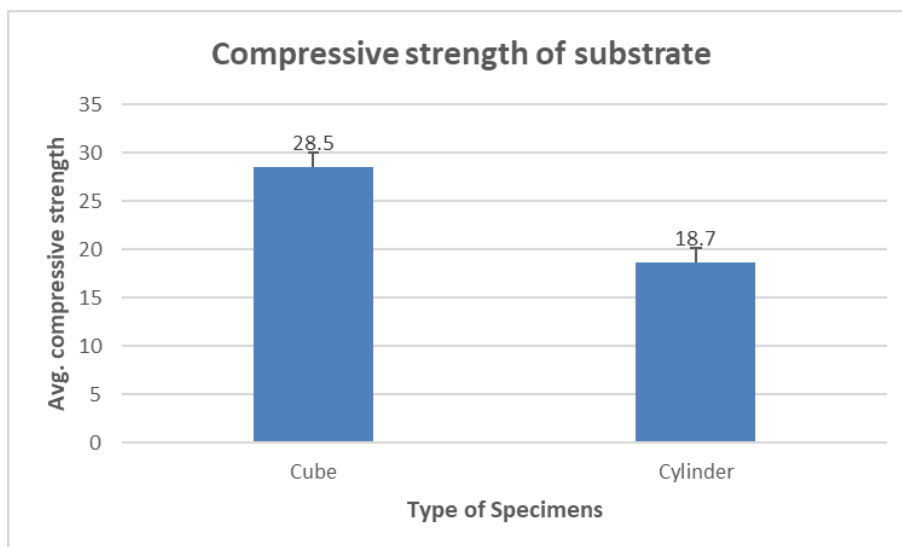
Fig: 10 Graph of Compressive strength of substrate materials

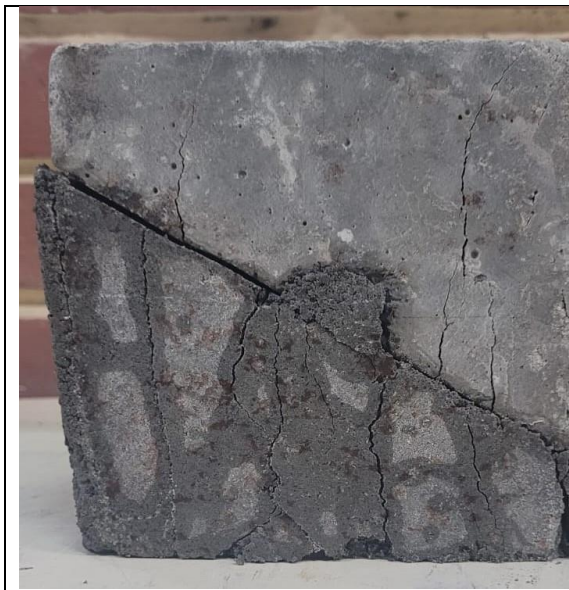
Fig:11 Interfacial failure between substrate and Asian paints repair material at predetermined plane of 30° along with vertical cracks

However, the observed failure in the specimen in **Fig:11**, which includes cracks in both the repair material and the substrate, indicates a failure under high normal stresses. Despite the strong shear adhesion, the high normal stresses lead to tensile or compressive failures. Addressing issues such as material compatibility, surface preparation, and structural defects is essential to mitigate stress concentrations and prevent crack formation, ensuring the long-term durability and performance of repaired structures.

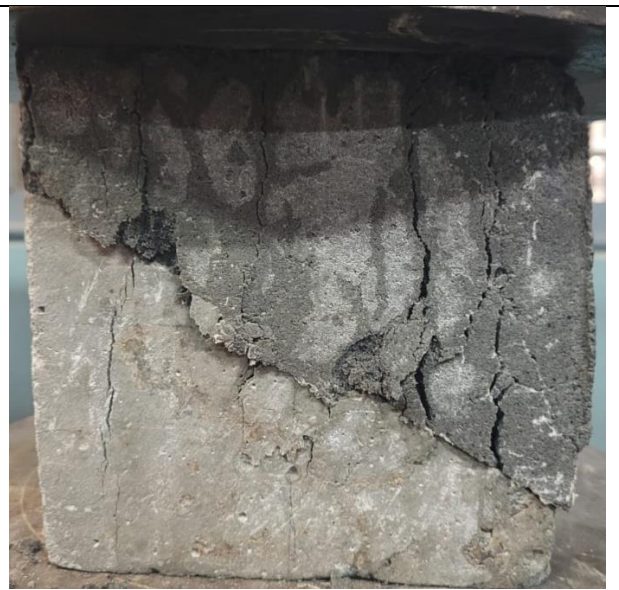
Fig: 12 Failure in the Asian paints repair material bonded to substrate at predetermined plane of 30°

dominating the failure mechanism. From **Fig: 12** the occurrence of failure within the repair material itself, rather than at the interface with the substrate, indicates that the stresses within the repair material exceeded its capacity, leading to material failure. This balanced failure mode suggests that both tensile/compressive and shear stresses contribute to the overall failure mechanism. To prevent such failures, it's crucial to ensure the repair material's compatibility with the substrate.

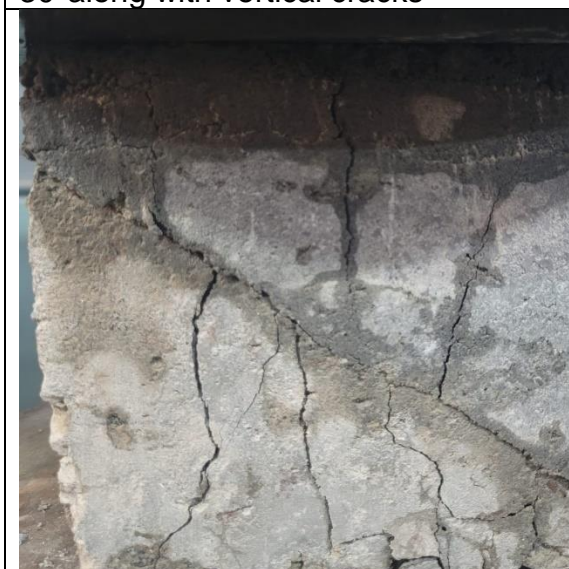
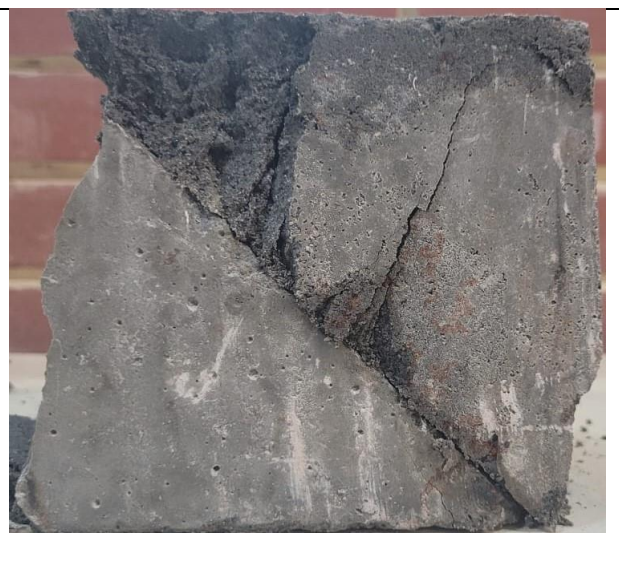
<p>Fig: 13 Substrate fracture and failure in the Asian paints repair mortar bonded to substrate at predetermined plane of 30°</p>	<p>Fig: 14 Failure in the Asian paints repair material of a specimen bonded to substrate at predetermined plane of 45°</p>

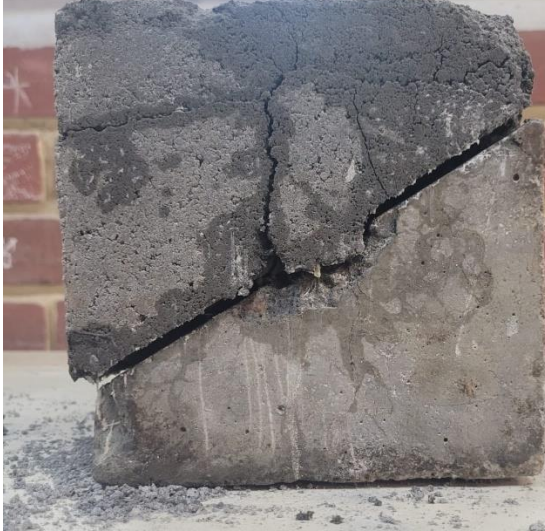
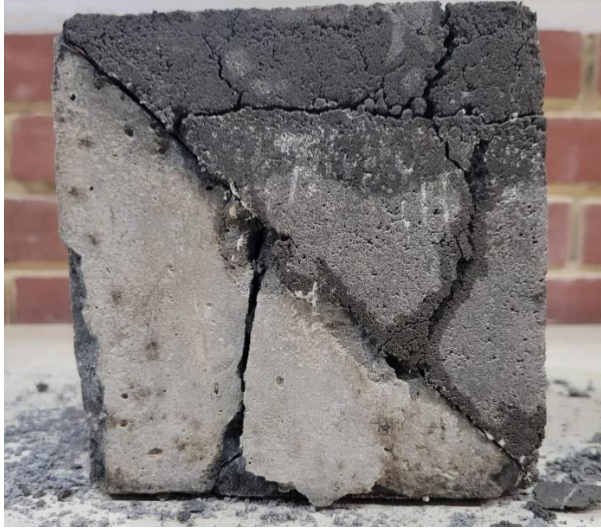
<p>Fig: 15 Interfacial failures between substrate and PPC repair material at a predetermined plane of 30° along with vertical cracks</p>	<p>Fig: 16 Substrate fracture and PPC repair material failure bonded to substrate at predetermined plane of 45°</p>

At a 45° orientation in BM bonded to the substrate, failure occurred in both the repair material and the substrate surface with observed normal and shear stresses of 5.26 N/mm². From **Fig:16** this indicates that both normal and shear stresses were significant contributors to the failure. The equal values of normal and shear stresses imply that the interface and the materials themselves were equally stressed, leading to a failure that is not solely interfacial but also within the materials. This highlights the need for improving the mechanical properties and bonding efficacy of the repair material to enhance overall structural integrity under combined stress conditions.

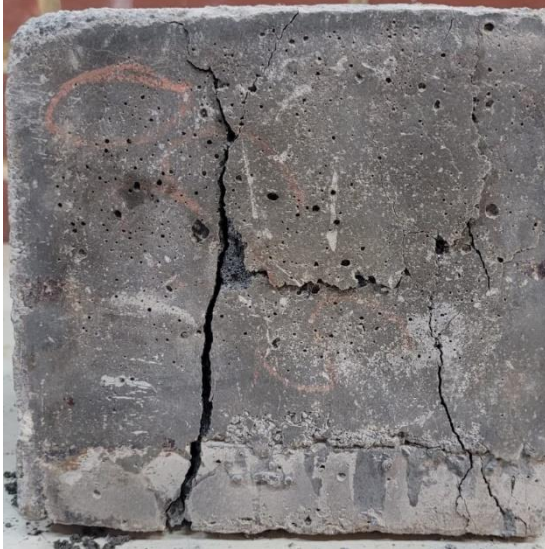
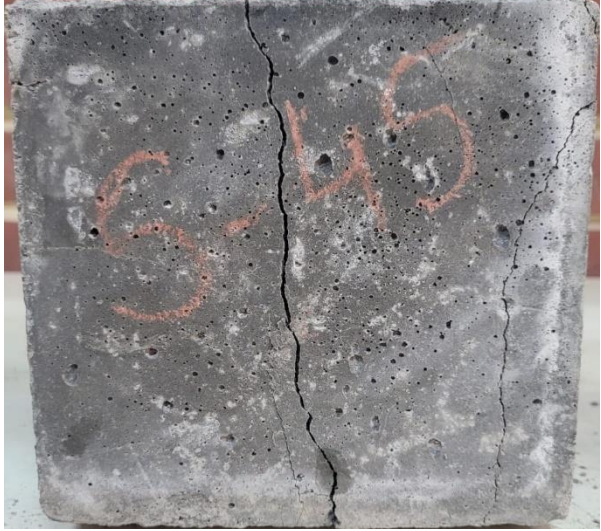
<p>Fig: 17 Substrate fracture and failure in the Sika repair mortar bonded to substrate at predetermined plane of 30°</p>	<p>Fig: 18 Substrate fracture and failure in the Sika repair mortar bonded to substrate at predetermined plane of 45°</p>

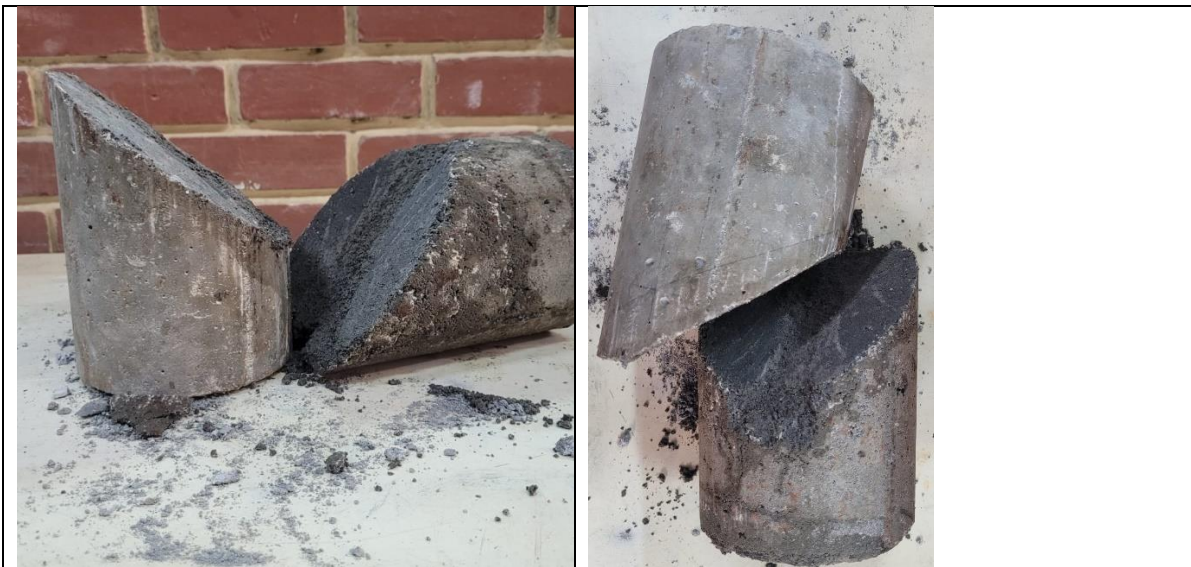
Fig: 19 Interfacial failures between substrate and Asian repair material at a predetermined plane of 30°

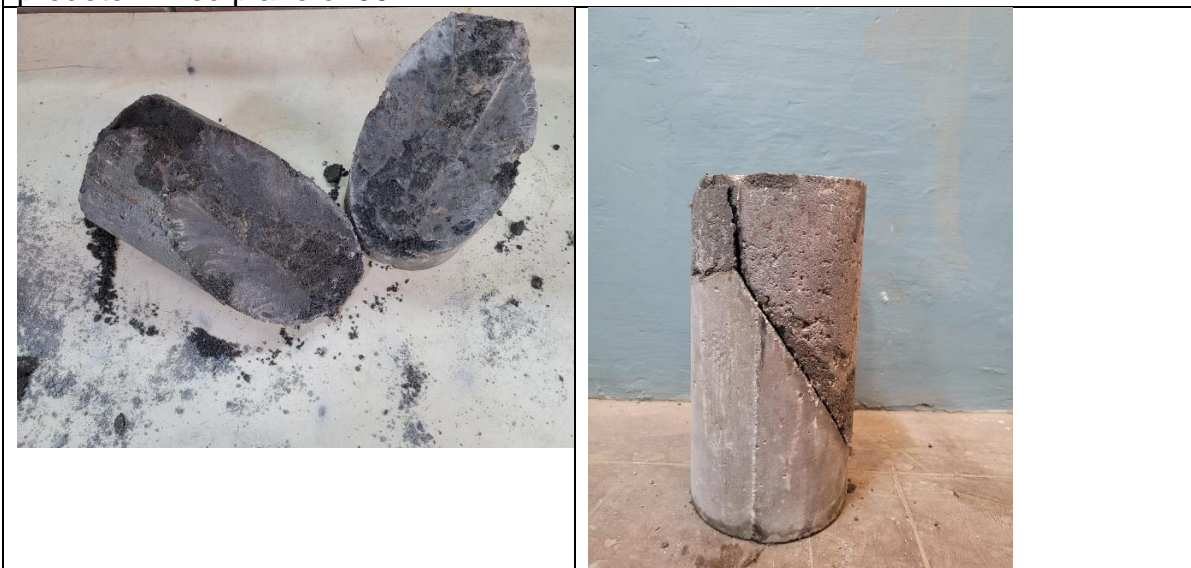
Fig: 20 Interfacial failures between substrate and Asian repair material at a predetermined plane of 45°

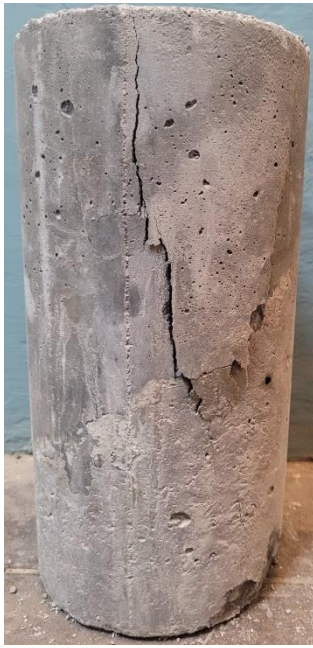
Fig: 21 Failure in the sika repair material bonded to substrate at predetermined plane of 30°

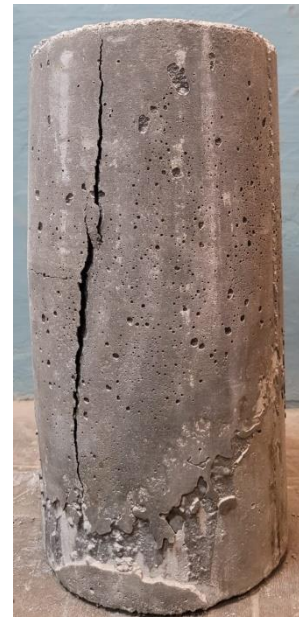
Fig: 22 Failure in the sika repair material bonded to substrate at predetermined plane of 45°

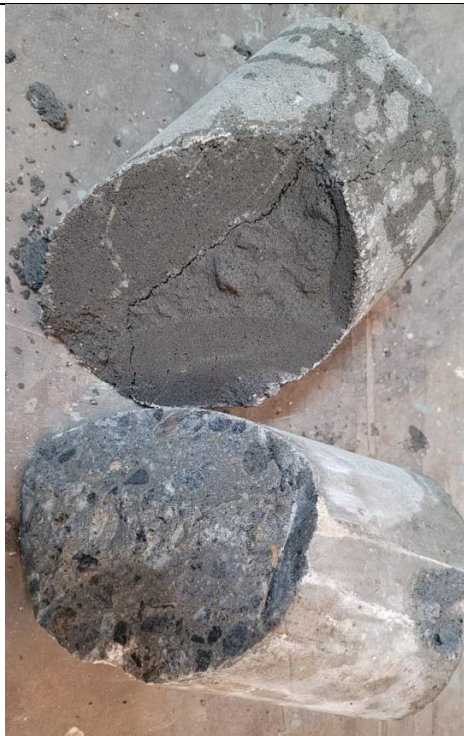
Fig: 23 Interfacial failures between substrate and PPC repair material at a predetermined plane 30°

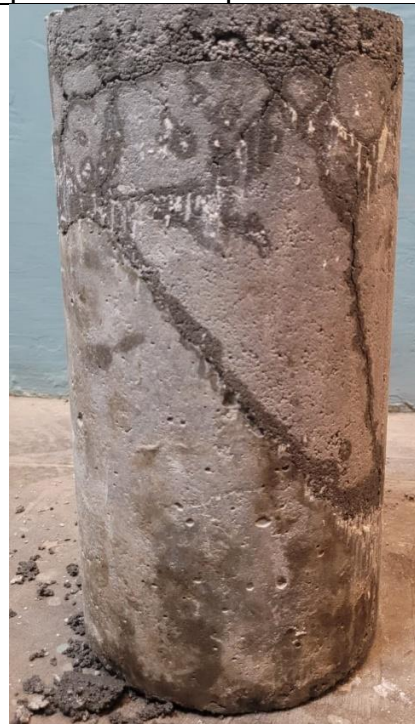
Fig: 24 Failure in the PPC repair material bonded to substrate at predetermined plane of 45°
